SUBJECT: Animal Feeding Operation (AFO) Compliance Inspection for – Prestage Farms of Iowa P278,
County – Franklin, – Facility #65299

AFO INSPECTION REPORT

FACILITY LOCATION	Facility: Prestage Farms of Iowa P278			Facility ID#: 65299	
	Address: 2309 135th St.		City: Geneva	State: IA	Zip: 50633
	PLSS: Section 2, Geneva Township (T91N, R19W), Franklin County				
OWNER	Name: Prestage Farms of Iowa, LLC				
	Address: 1421 S Bell Ave.		City: Ames	State: IA	Zip: 50010
ANIMAL HOUSING TYPE	<input checked="" type="checkbox"/> Confinement <input type="checkbox"/> Open Lot <input type="checkbox"/> Combined (Confinement & Open Lot)				
ANIMAL INFORMATION	Animal Type(s)	Capacity	Current Head	Number of Bldgs./Pens	
	Swine	4800-Head	4800	1 - Building	
	Date of Construction: 2007		Date of Expansion: N/A

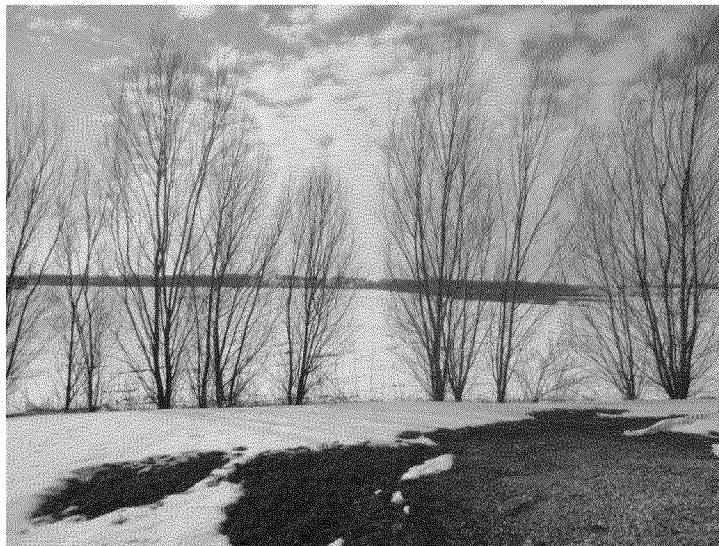
During my on-site inspection, I did not observe drainage tile surface intake(s) on-site or in the immediate vicinity of the facility. Site drainage appears to be to the south, and potentially to the east and then south; however, the surrounding topography is considerably flat and the nearest water source, Maynes Creek, is located approximately 4600-feet to the south of the facility. Consequently, unless unobserved tile intakes exist, the chance of site runoff resulting in a discharge of pollutants to Maynes Creek appears unlikely.

Looking south to Maynes Creek (tree line in distance to left of photo) – showing flatness of topography

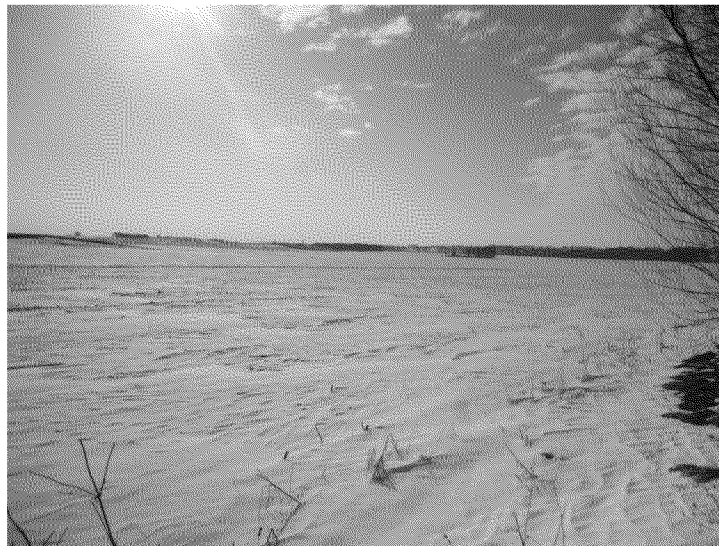
Looking east/southeast toward Maynes Creek (tree line in distance to right of photo) – showing flatness of topography

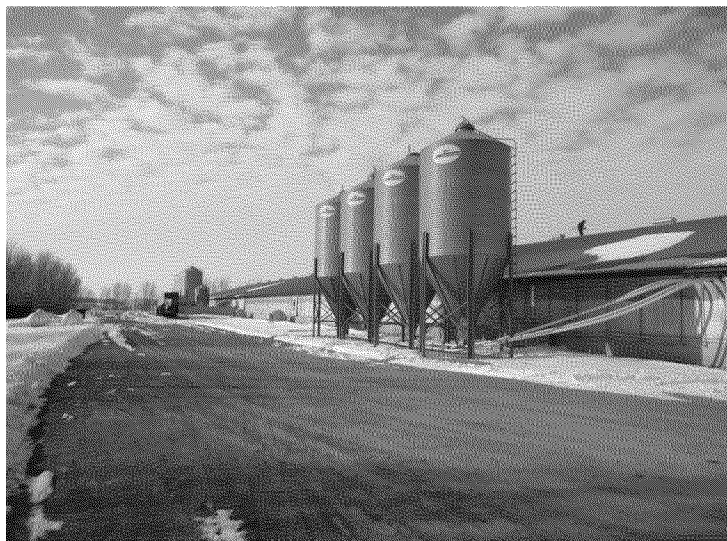
During the inspection, I observed the bulk bin feed system serving each building. All bins, feed conveyance pipes and various attachments appeared to be intact and effectively containing feed. Still, this part of the operation should be inspected frequently, as runoff water could carry spilled feed into a water course where it could create violations of state water quality standards. Discharge of such process water would potentially require an NPDES permit.

East end of building and feed storage bins

- 1) Inspect manure storage structures, carcass disposal areas and feeding system components on a frequent and regular basis as the discharge of pollutants from these areas could potentially require a National Pollutant Discharge Elimination System (NPDES) permit.

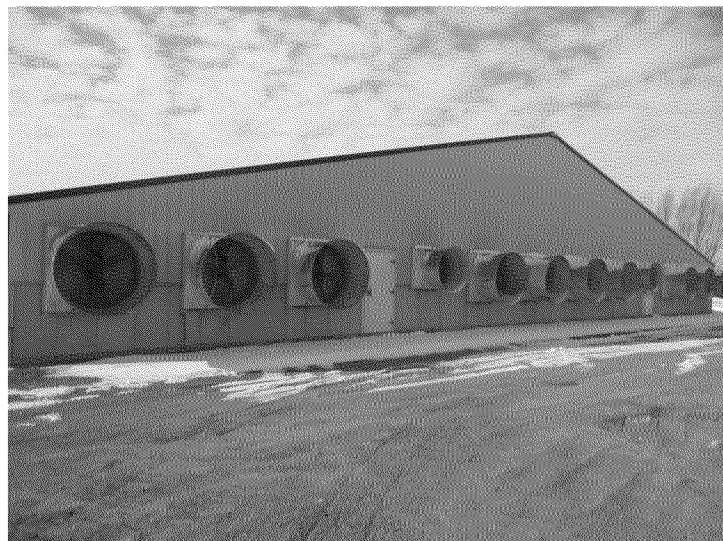
During the inspection, the building was observed. I observed that portion of the concrete which was visible above-ground. This amounted to approximately 2-feet of concrete, which would be above the slats covering the below-building deep pits. The observed concrete appeared to be structurally sound and I did not observe any evidence of manure discharges from or in the vicinity of the building. I observed no evidence of cracking, excessive spalling or other issues of concern regarding the visible portion of the concrete.

North end of building and building ventilation fans

While no evidence of discharge was observed during this inspection, it is recommended that the manure storage structure be inspected for discharges and needed repairs regularly, as confinement feeding operations must contain all manure produced between periods of application. As stated above, any discharges may require an NPDES permit for the operation.

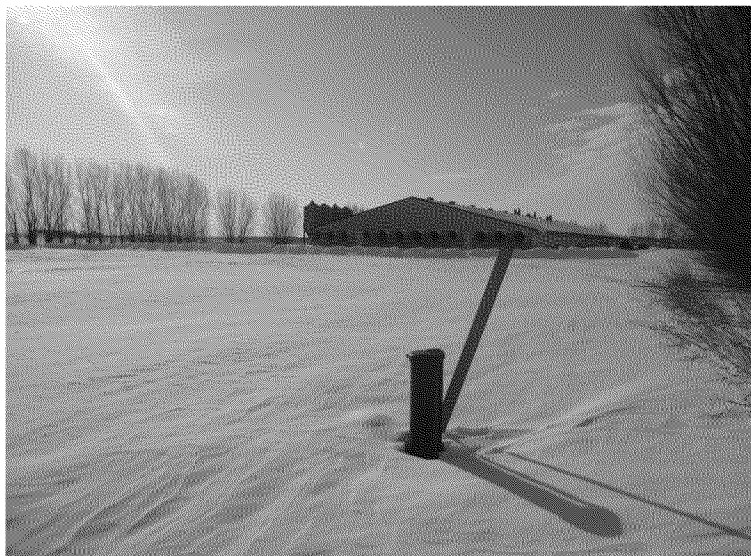
The water well serving this facility is located approximately 200-feet northwest of the confinement building. The area between the well and the building is significantly flat. Additionally, although there was snow cover on the area at the time of the inspection, historic aerial photography and general site observations indicate the area is vegetated (mowed grass). The combination of distance and vegetative ground cover should provide some measure of well protection from contamination due to a discharge.

Looking southeast from well to building

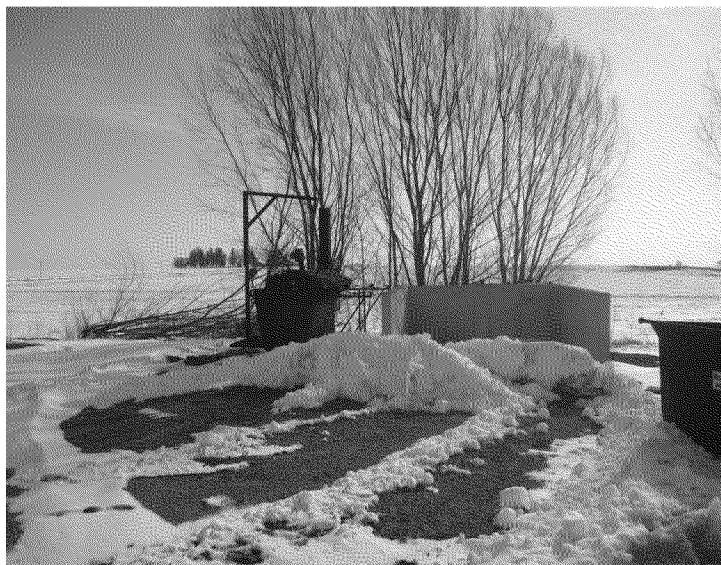
Carcasses were historically incinerated at this facility, however the incinerator has not been utilized in many years. Currently, carcasses are rendered on-site. There is a dead box located on the east side of the building, on the packed gravel drive. The surrounding area is particularly flat and I observed no tile intakes in the area. Therefore, it appears to be in a good location with regard to the potential for surface runoff. No carcasses were visible at the time of the inspection.

Defunct incinerator and ash storage structure

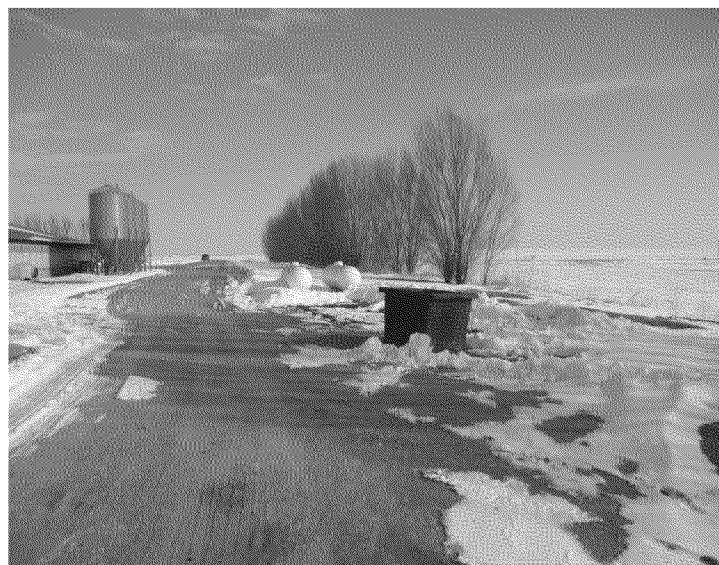
Currently-utilized rendering dead box
